Manhole Inspection Summary

Manhole # S29I__058MH

Insp Date: **4/6/09 11:02 AM**

Location Address: **S MLK JR BLVD**

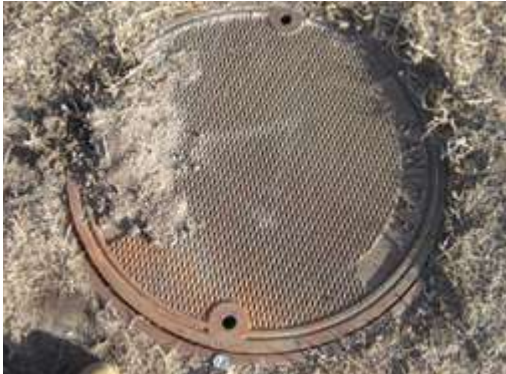
MH Cover

Type: **Sanitary** Condition: **Sound** Cover Material: **Cast Iron**

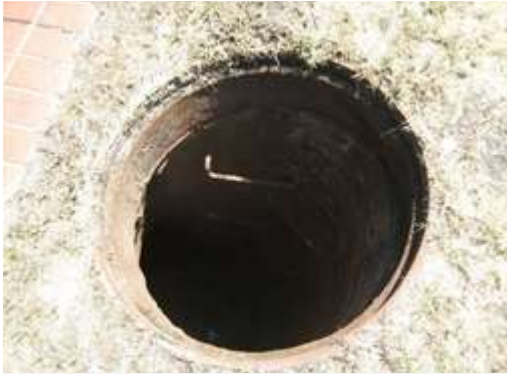
Frame View

Frame Offset: **0** (in.) Condition: ☒ Sound ☐ Cracked ☐ Leaks

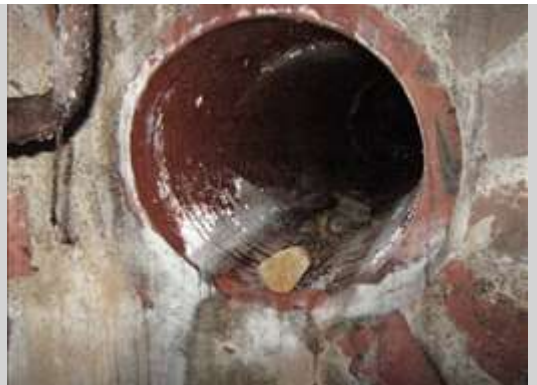
3 O'Clock Inflow

Pipe Height: **8.4** (in.) Rod and Bar (Angled)

Invert Depth: **10.31** (ft.) Flow Characteristics: **Fast**

Deposits: ☒ None ☐ **Mud** ☐ **Sludge** ☐ **Debris** ☐ Grease

Infiltration: **None** Pipe Seal Cond: **Sound**

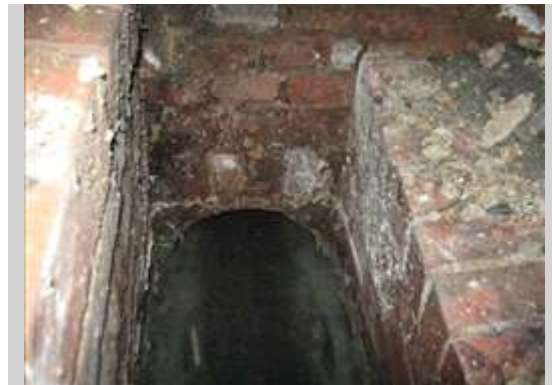
Drop In @ 3 O'Clock

Drop: **Outside** **Rod and Bar**

Angled: **Yes** Reading: **12.94** (ft.)

Drop Condition: **Open**
